## The Triemstra Barn: Probing Connections to Fort Winnebago

Adam Novey, June 3, 2021

## INVESTIGATING A FAMILY LEGEND

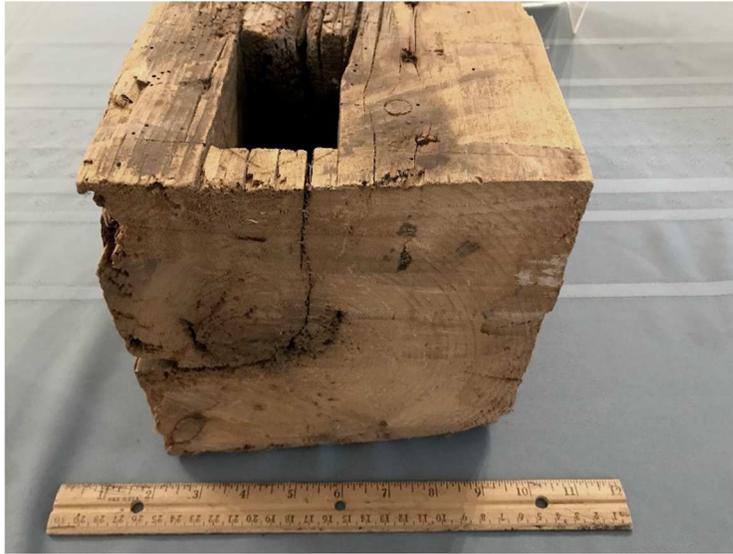
FIGURE 1: Baseline Period Building Characteristics Present in Agency House

Beam section removed from the Agency House during its 2012 restoration. Ruler placed for rough scale. Note joint mortise. Beam segments surviving in the Agency House collection vary in dimension and proportion, ranging from 3" in width to 8".

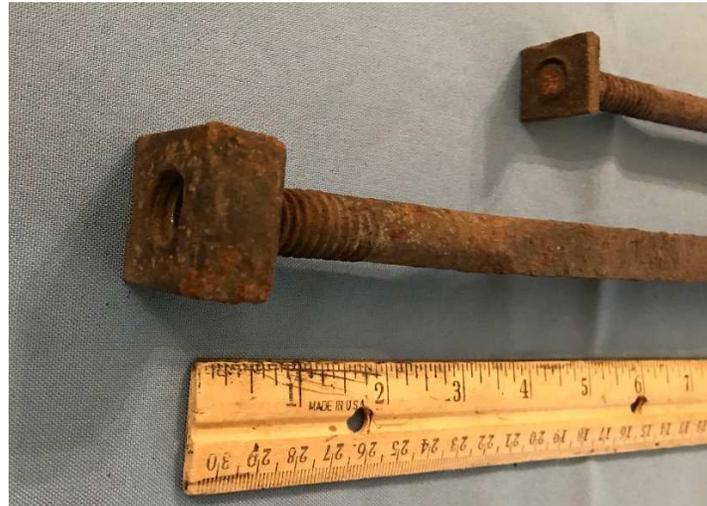
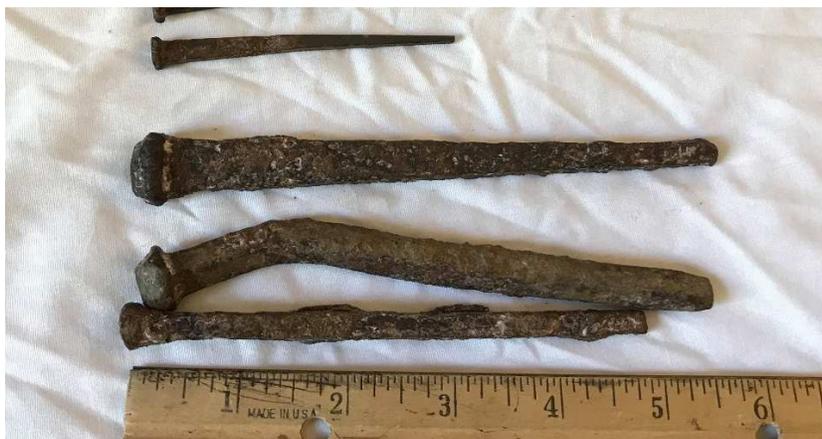
Forged iron bolts of known Fort Winnebago provenance. The bolt on the left would accommodate a 12" beam. Note particularly the filed threading, massive square nut, and square head.

Cut nails and forged iron spikes from the Agency House. Spikes were known to attach building hardware (shutters, etc.), and nails to attach lath and roofing.

Cut nails and hand-forged spikes were used as secondary fasteners in constructing the agency building. A set of massive hand-forged bolts with a fort provenance is housed in the Agency House collection, with one which had an interior span (between the square nut and the head) of approximately 12 inches (fig. 1). Forged spikes of similar provenance are also held in the collection.

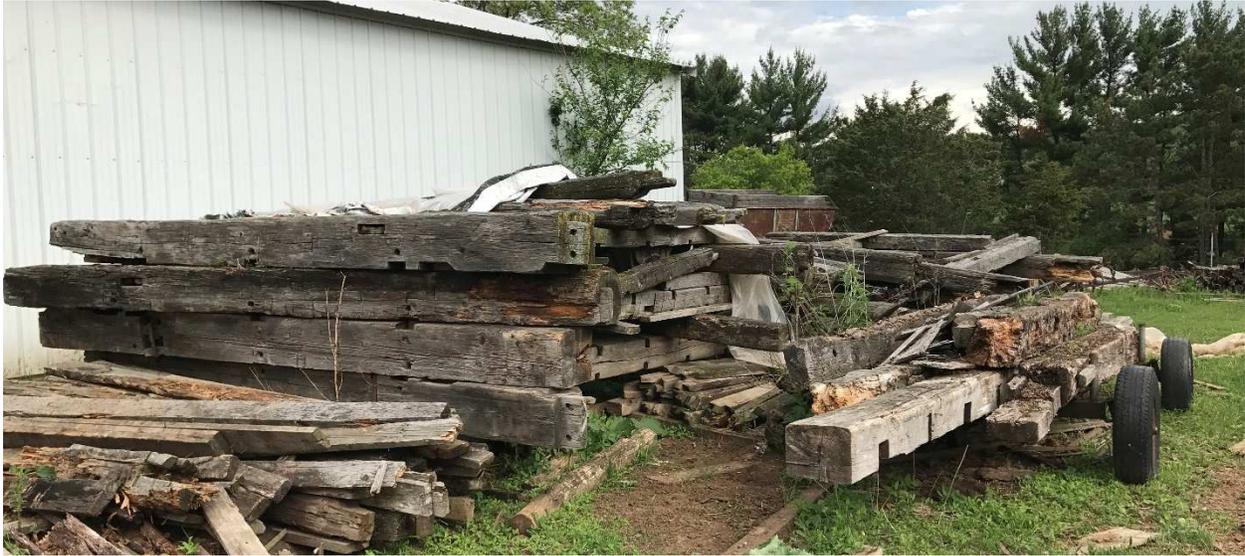
**FIGURE 2: Surviving Structural Components of Triemstra Barn**

Overall View

The Triemstra barn exhibits remarkable consistency with this overall scheme of construction (fig. 2). The timber frame “bents” which compose the largest surviving pieces of the building are made of pine beams squared by hand. While slightly larger than the largest beams of the Agency House, the beams match the span of the bolts from Fort Winnebago described above and pictured in figure 1. They are assembled with mortised joints which are fastened with wooden pegs (hardwood and possible pine). The upper joints of the uprights were reinforced with forged iron bands which are secured through the beam with long bolts almost identical in size and manufacture to those which are housed in the Agency House collection. The nuts on the bolts used in this instance are forged to the (presumably threaded) shaft. As an aside, assuming the provenance of the building is correct, this use of the bolts actually provides the most probable hypothesis for how the bolts in the Agency House collection were employed, since their use was previously a matter of speculation.

The final question then becomes, *can* it be saved? The building no longer stands, but major structural components (comprising upward of 50% of the building) survive. Photos of these massive structural elements (fig. 2) illustrate the effect which the elements have had upon them. Some individual timbers are beyond repair, but it is the opinion of the Amish men who dismantled it that the old-growth heartwood within the timbers is sound enough for reconstruction, assuming the joints are addressed and—if warranted—reinforced. If faithfully reconstructed, the cost would be high and new components would have to be sourced to replace those which have fallen victim to time. While it is doubtful whether immediate space or funds are present for such a monumental undertaking to come to fruition, this building is too important not to receive every chance for some form of preservation, even if it entails only smaller components of the remains of the building being exhibited and interpreted in one or more of Portage's three main public history venues. Perspective on this historic building is not hard to maintain. This piece of history is at a crossroads and, as is well known in historic preservation, once it is gone it can never be replaced.

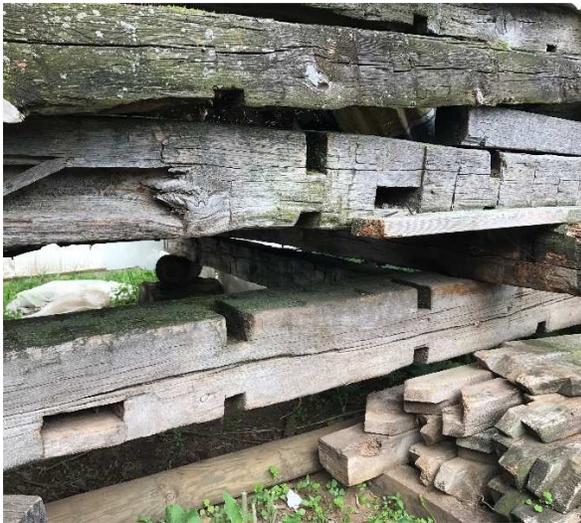
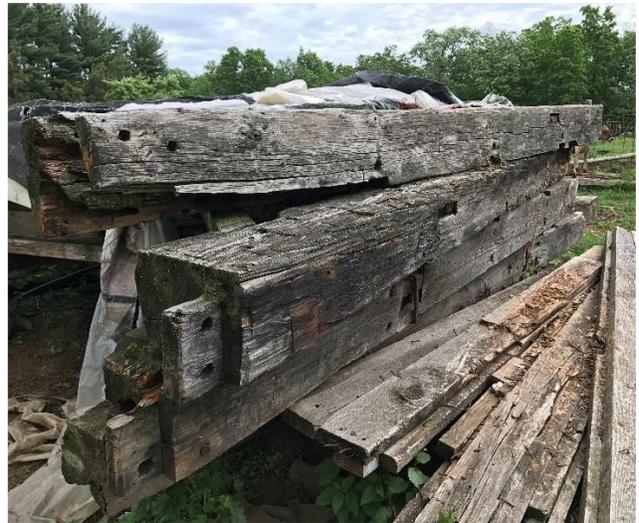
Left: Mortised sockets for joists of second floor. Right: Tenons for sill beam (no longer extant). Note hand-hewn nature of beams.

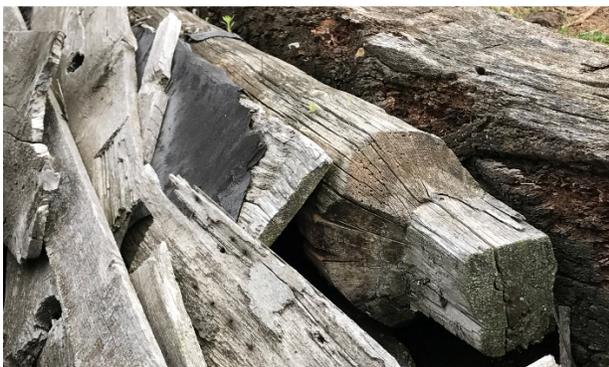
Round log upright stud. S\_\_\_\_\_ believed that the round-log studs present in some areas of the building post-date the initial construction.

There are two or so examples of this round-log material which survive in the building's remains.

Jefferson Davis' layout it is apparent that multiple bents would have had to be constructed without such supports since they would have coincided with the middle of rooms (fig. 6). Since the upright supports of the Triemstra barn are likely later additions (some being round logs, strongly indicating a post-construction addition), and the timbers are of such a size and design as to make them structurally unnecessary prior to the structure's aging, the placement of partition walls according to Davis' plan is not problematic under the assumption that the uprights present during the farm-era were added later for stability.

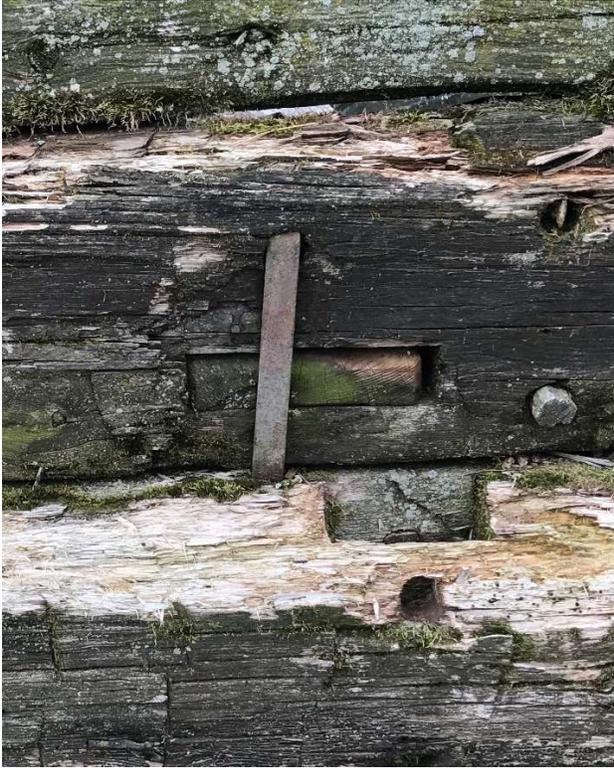
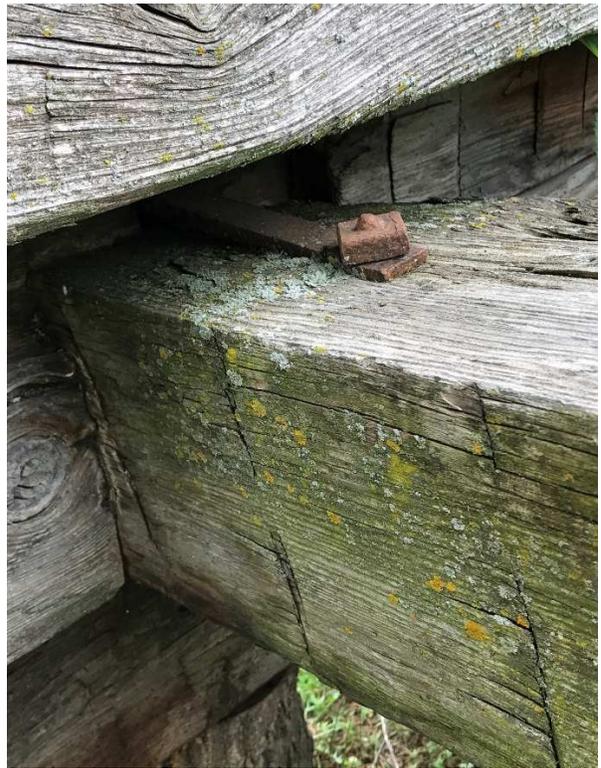
Wrought iron band reinforcing a mortised joint. Note the square bolt which fastens this component. Also note the pegs to the right of the joint and the peg/mortise holes in the lower, more deteriorated beam.

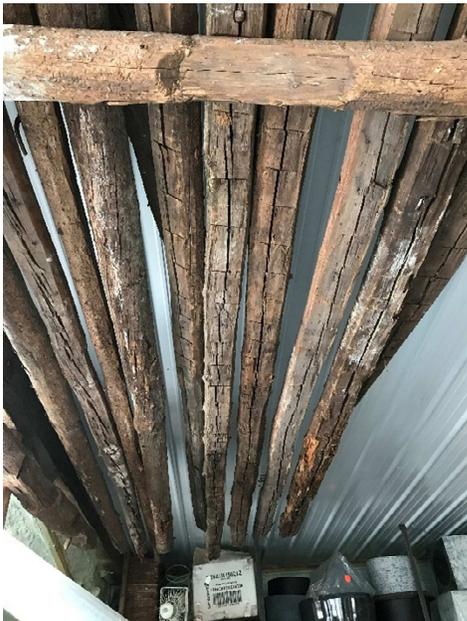
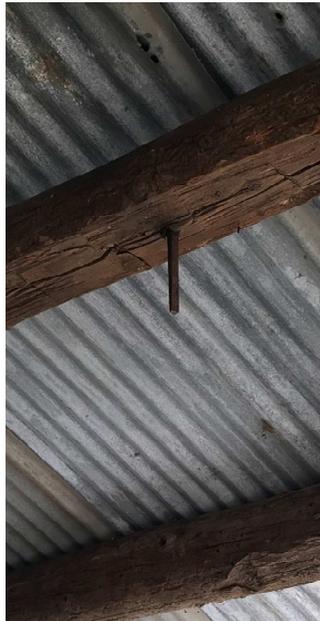
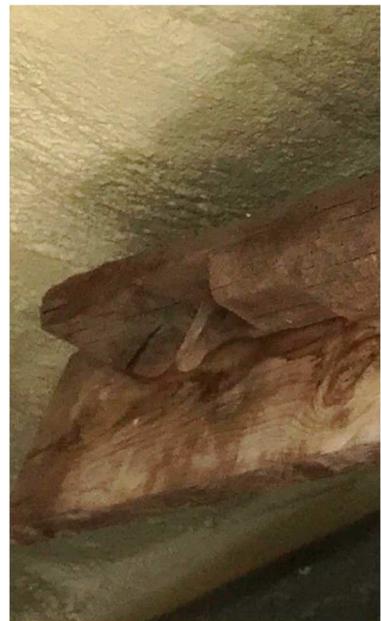
Rafter poles of round tamarack squared on one side. Note iron spike, nails, and pegs.

The rafters of the structure are round logs which have been squared on one side. They are believed by their present owner to be tamarack, which is of significance. Their age is indicated by their wooden peg attachment and the surviving square cut nails and spikes (also roughly matching a few with fort provenance in the Agency House collection) which are still embedded along their length after the removal of the deteriorated roofing.

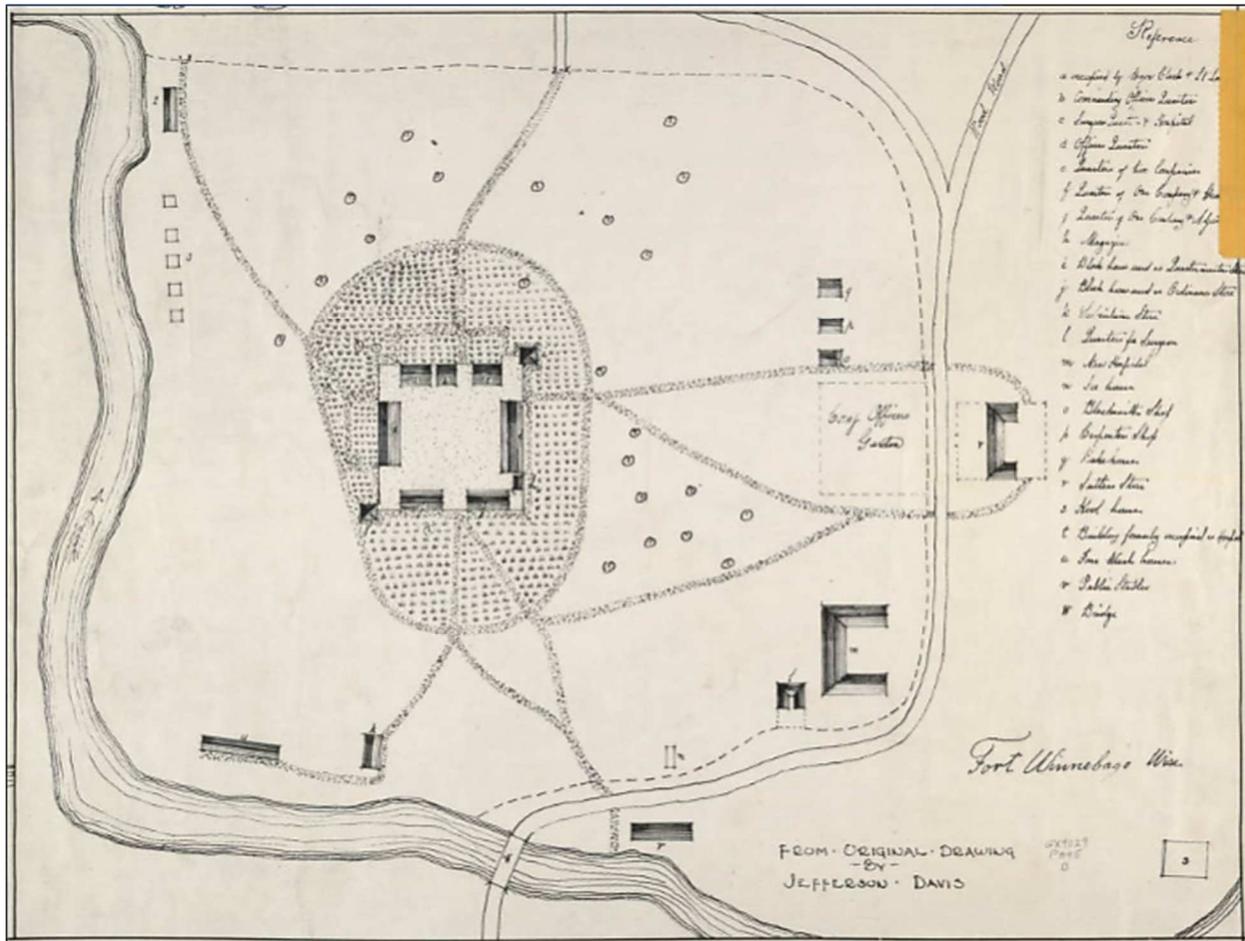
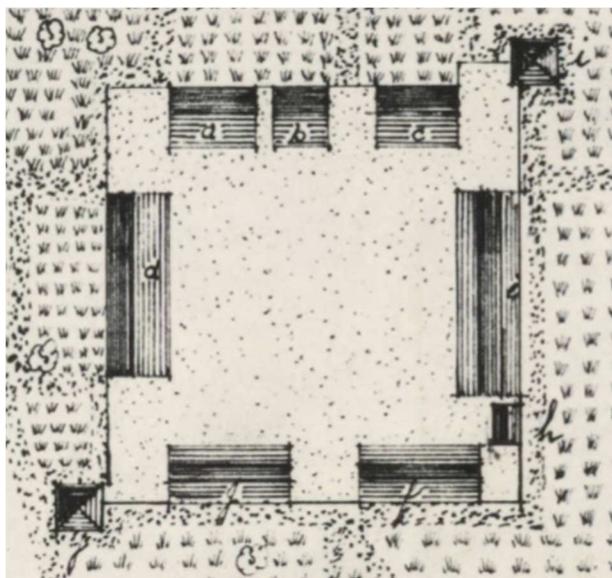
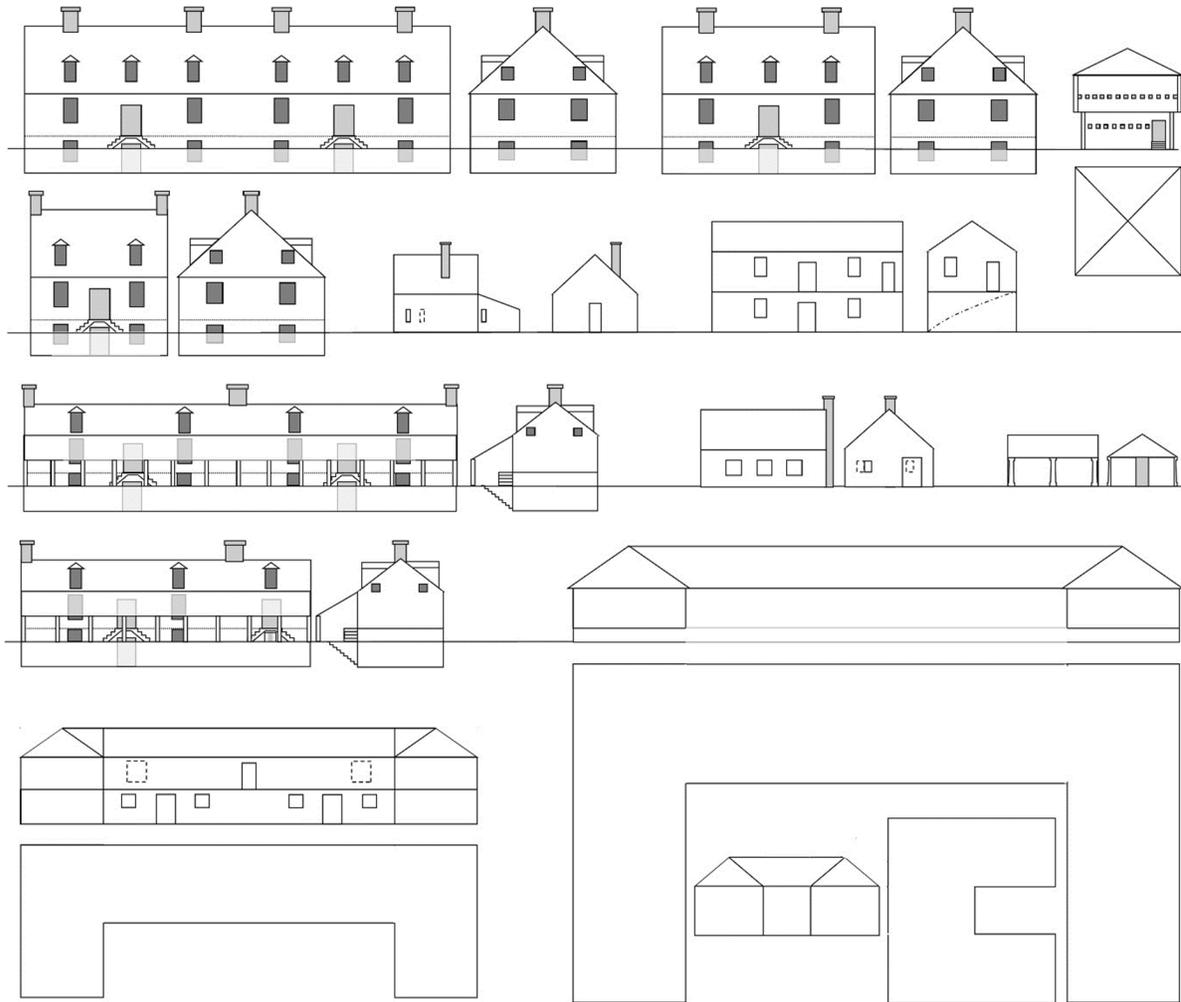
FIGURE 3: Illustrations of Fort Structures by Jefferson Davis, 1830

Buildings a, b, c, and d share a width of 35'. The enlisted quarters opposite these buildings are approximately 20' in width not inclusive of the covered porch delineated in the sketch. Other buildings visible in the overall illustration of the fort complex are all under 30' in width excepting those addressed above.

Buildings a and c both match the Triemstra barn's dimensions closely and were two identical buildings as illustrated in the below sketch (fig. 4)

Scale (rough) 1":42.5'

Fort buildings varied in size, although less-so in general profile and design. Of the approximately 20 buildings making up the fort (fig. 3), 15 were under 30 feet wide, most being significantly closer to 20' in width. Of the five that approach 35' in width, the Surgeons Quarters which still stands must be subtracted, as must be the commanding officers' quarters which was only 29' long.

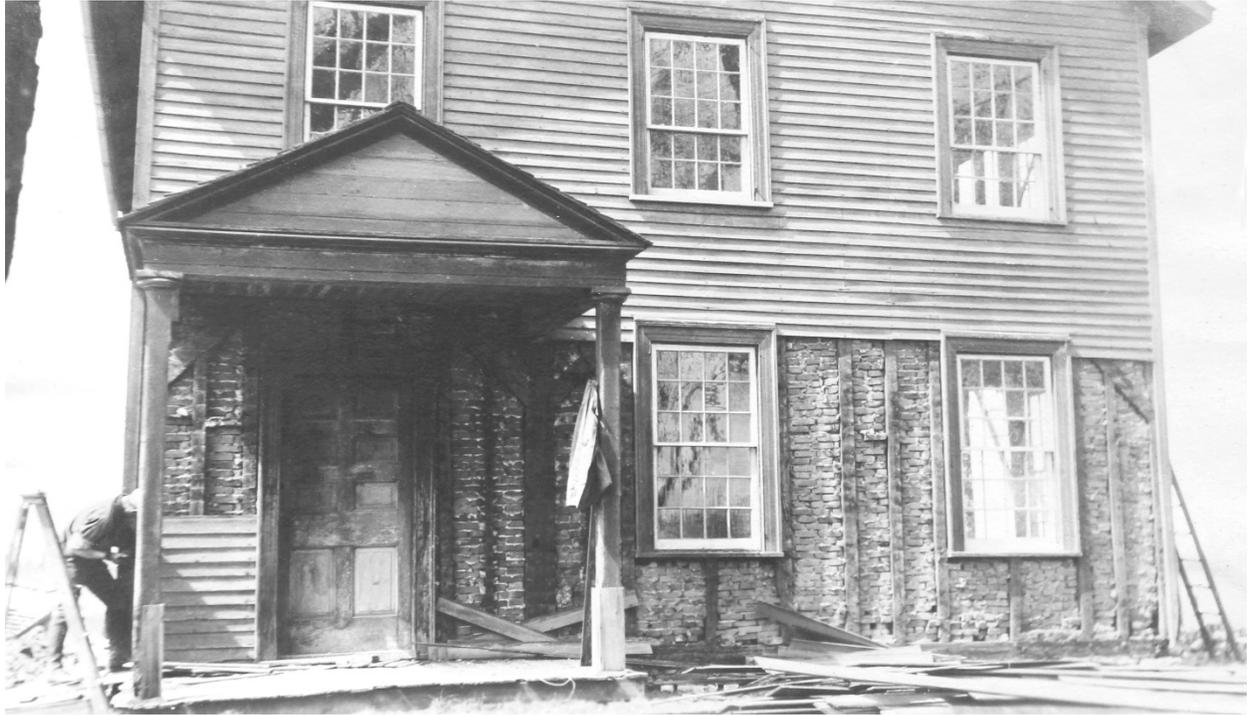
FIGURE 5: Brick Insulation Example

Bricks insulation between studs on the first floor of the Fort Winnebago agency house.

The Agency House also utilized this insulation technology (fig. 5). The Triemstra barn in its moved state had neither lath/plaster, nor brick insulation, but this does not pose a significant problem. To move such a building (particularly with the intent to use it as a barn in its new location), the brick insulation would have been removed on site prior to its transit. In the process of doing this, the lath covering the studs would need to be removed and not replaced since the building was to become a barn. A legitimate question then arises as to what evidence might remain of such plastering and mortared brick insulation on the surviving woodwork. In this case, the Agency House becomes an important point of comparison. In 1932, many of the bricks within the walls were removed for restoring the home's fireplaces.<sup>12</sup> Now, only ninety years later, samples of beams which have been removed from the house during the 2012 restoration, as well as pieces that are visible in wall-cutaways show no residual grout adhering to them. Whether the grout/plaster was not in contact with the wood due to the intermediate lath, or in the case of insulation, the bricks themselves, or whether it is due to the unstable nature of the material, the surviving beams are clean, as though they had never been subject to this building treatment.

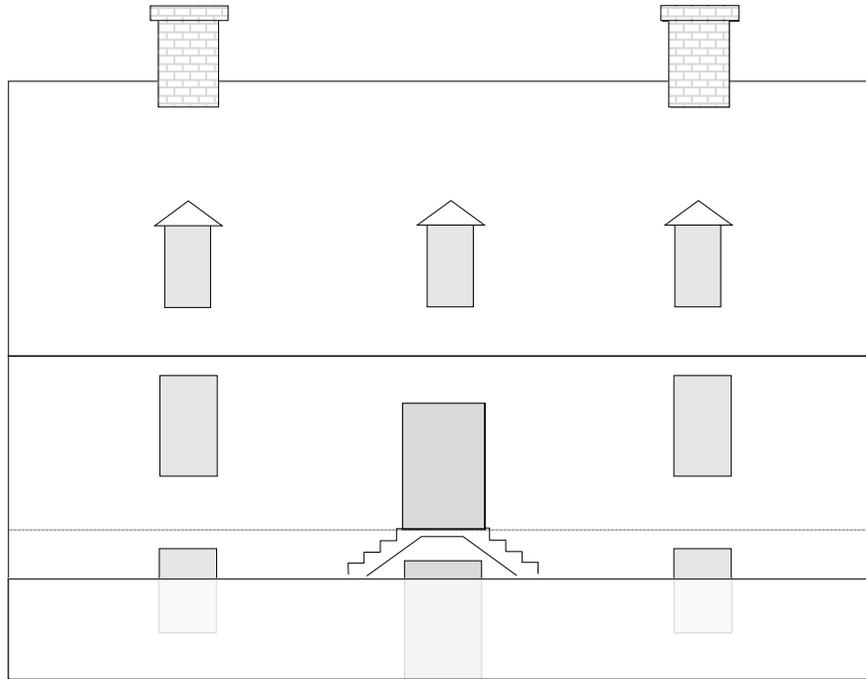
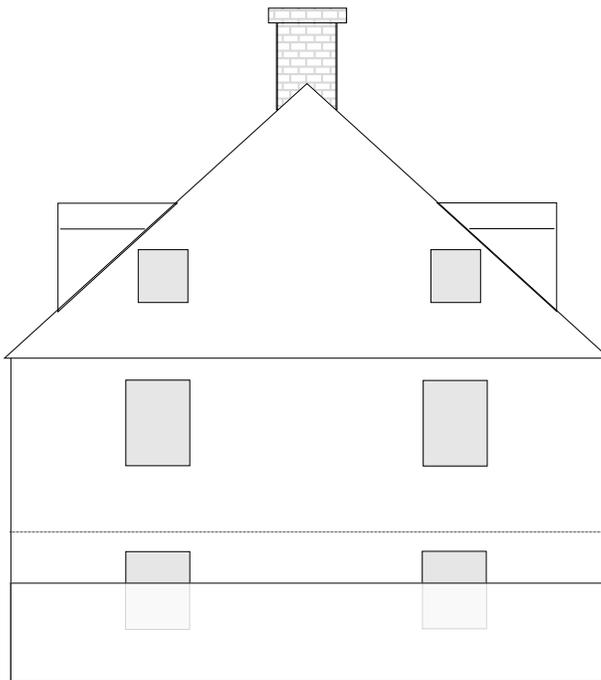
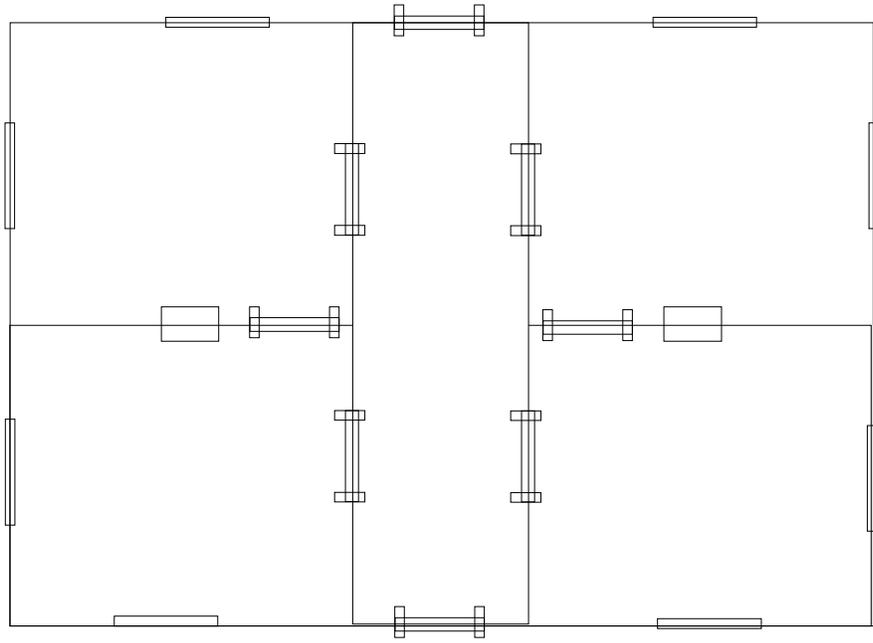
FIGURE 6: Fort Winnebago Officers' Quarters Plans Based on Jefferson Davis' Blueprints

—appx. 53 feet based on rough scale—

-----Height of Second Floor on Davis illustration

-----Height of stone foundation on Davis illustration (actual above-ground profile in question: see fig. 5)

—appx. 35 feet based on rough scale—

Floor Plan (as per Davis' October, 1830 Illustration)

As to the lighting of the "garret" level, dormer windows were present on all barracks (fig 6). For the officers' quarters in question, these appear to have been arranged with three in front and two in back of the building.<sup>14</sup> These were not present on the Triemstra barn. However, in discussing a separate issue with Mr. S\_\_\_\_\_, he mentioned that he remembered a handful of areas of roof sheathing which had been patched at some point in the building's past. One was drawn on his illustration (fig. 7), but he pointed to two other areas along the slope of the roof which he also recalled as being replaced (although he could not exactly pin them down on the sketch). These generally located points roughly correlate with where the dormer windows appear on Davis' illustration. With nearly one half of the roof having been replaced at a later date, similar data for the other end of that slope and on much of the other side of the roof is not available. It is also unknown whether there were any irregularities in rafter placement along the length of the building suggestive of these features. In its use as an agricultural building, the disappearance of dormers would not be a surprise, and with the above evidence of disturbance at likely areas, this is not entirely problematic.

What is more significant is the number of bents in this structure. With five bents, one would logically be placed in the center of the building. This arrangement would be extremely problematic in that the officers' quarters were built with a central hall and exterior doorways on either side of the building's midpoint (fig. 6). However, this is where another piece of previously unrelated information garnered from Mr. S\_\_\_\_\_ becomes significant. In describing the building, S\_\_\_\_\_ recalled that the spacing of the bents across the length of the structure was completely unorthodox. The two spaces between bents on one end of the building were equidistant at twelve feet on center of beam, but the other side's bents were spaced approximately fourteen and thirteen feet, respectively (fig. 7). This quirk in the building design makes no sense unless considered in light of the officers' quarters floor plan. With the number of bents being determined by building length, and not layout, this building hypothetically required five bents for structural integrity (as was present in the barn). To ensure that the middle bent did not interfere with the floorplan's central doorways, the bents on the right side of the structure could have each been built with marginal (although cumulative) extra space to allow for the central doorway. As is apparent in the Triemstra barn, this spacing allowed approximately three feet of space (possibly more depending on the preciseness of measurements) exactly in the center of the building which would have been free of beams, and suitable for a doorway. This nontraditional spacing of these five bents thus goes from being problematic to becoming compelling evidence which is only explained when looked at in light of the officers' quarters floorplan.

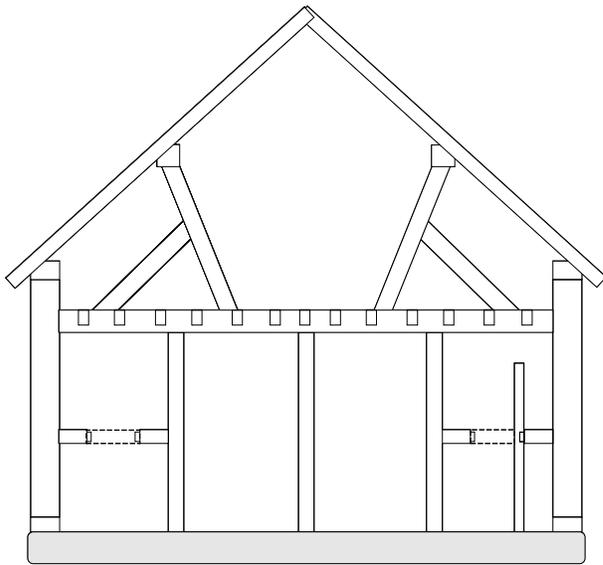
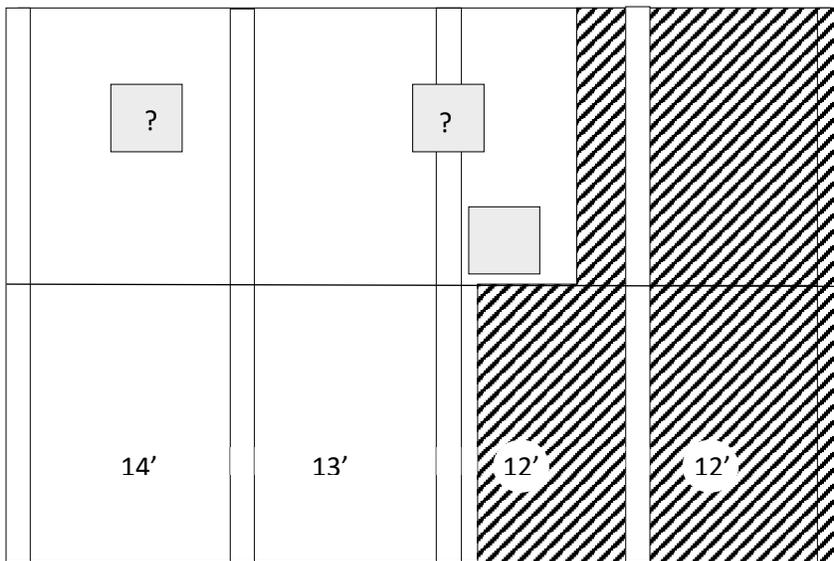
FIGURE 7: Sketch of original details by Wayne S----- (5/25/2021)

—appx 35 feet wide—

Tamarack rafters assembled with wooden pegs. Roof angle unknown. Mortised on top of the lengthwise beam and secondary support and attached with forged spikes and oak pegs. Sheathing attached with cut nails. Total wall height 16’.

Loft/second floor mortises on beams appx. 18-24” below top of uprights posts. According to S\_\_\_\_, these mortises do not appear to be a standard milled lumber mortise.

The cross ties illustrated were truncated with mortised ends. One upright door/window member was still attached.

When dismembered, it was sitting on a stone foundation. S\_\_\_\_ believed that the original structure would have had less of a substantial foundation, but that was based more on building relocation logistics than design.

—appx. 51 feet long—

S\_\_\_\_ drew a patched area appx. near the ridgeline (possible chimney?). Two other patched areas further down the roof also came to mind which are marked approximately, but with a limited degree of certainty.

Bay spacing measurements are from beam-center to beam-center.

Striped area was re-constructed in recent time (although on the same stone foundation as original).

The Triemstra Barn was approximately 35 feet wide and 51 feet long. It consisted of five bents spaced in an unusual sequence of 14, 13, 12, and 12 feet on center of beam. The last bent had been reconstructed after a structural failure in recent times but was presumably built on the same foundation as that which was prepared at the time when the intact building was moved to its new location. The sides from base of beam to the eaves was approximately 16' in elevation.

Another feature in the floorplan of the quarters is the presence of two fireplaces/chimneys. While these were not present in the barn, S\_\_\_\_\_ did recall a section of replaced roof sheathing near the ridge line which could be evidence of the past presence of a chimney aperture (fig. 7). Again, one end of the building's roof had been replaced, so it would be impossible to determine if a second was present.
